# Remediation of a Former Chemical Factory - Four Ashes, Staffordshire

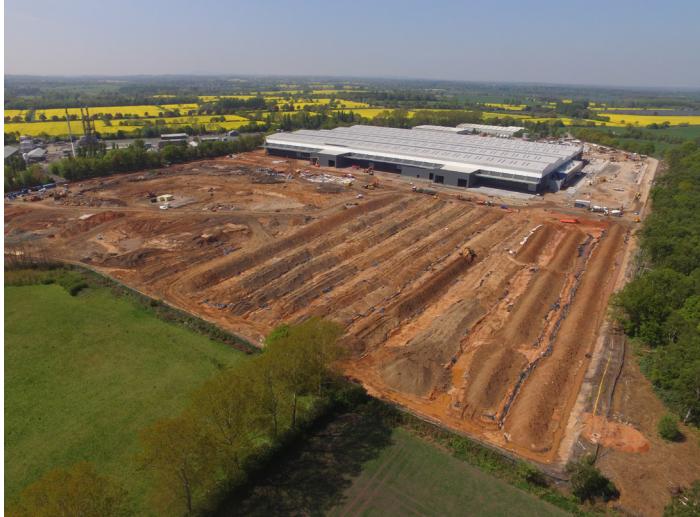
Figure 1: Four Ashes site in development

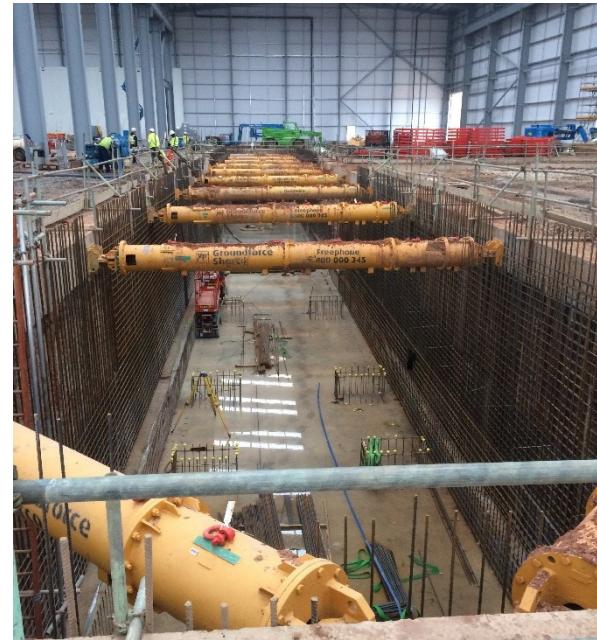
Figure 3: Seven metre deep press pit construction in manufacturing facility required the use of FLI QDS' water management expertise

A high water table and widespread groundwater contamination posed a major difficulty for the groundworks phase. QDS recognised that a comprehensive water management system was required in the early stages of the project's life.

Through active engagement with all stakeholders, infrastructure comprised of lagoons, drainage channels and three kilometres of pipework was used to abstract and pump water to a bespoke automated water treatment plant operated and maintained by QDS. 44,000m<sup>3</sup> of water was successfully treated and discharged into the neighbouring canal under consent from The Canal Trust.
